RE: Aquatic Resource Investigation Results
Canal Road Solar Array
Lot 6.02, Block 516
Franklin Township, Somerset County, NJ
RETTEW Project No. 108322044

AQUATIC RESOURCE INVESTIGATION

PROJECT NAME: Canal Road Solar Array **PROJECT NO.** 108322044

SUBJECT: Aquatic Resource Investigation

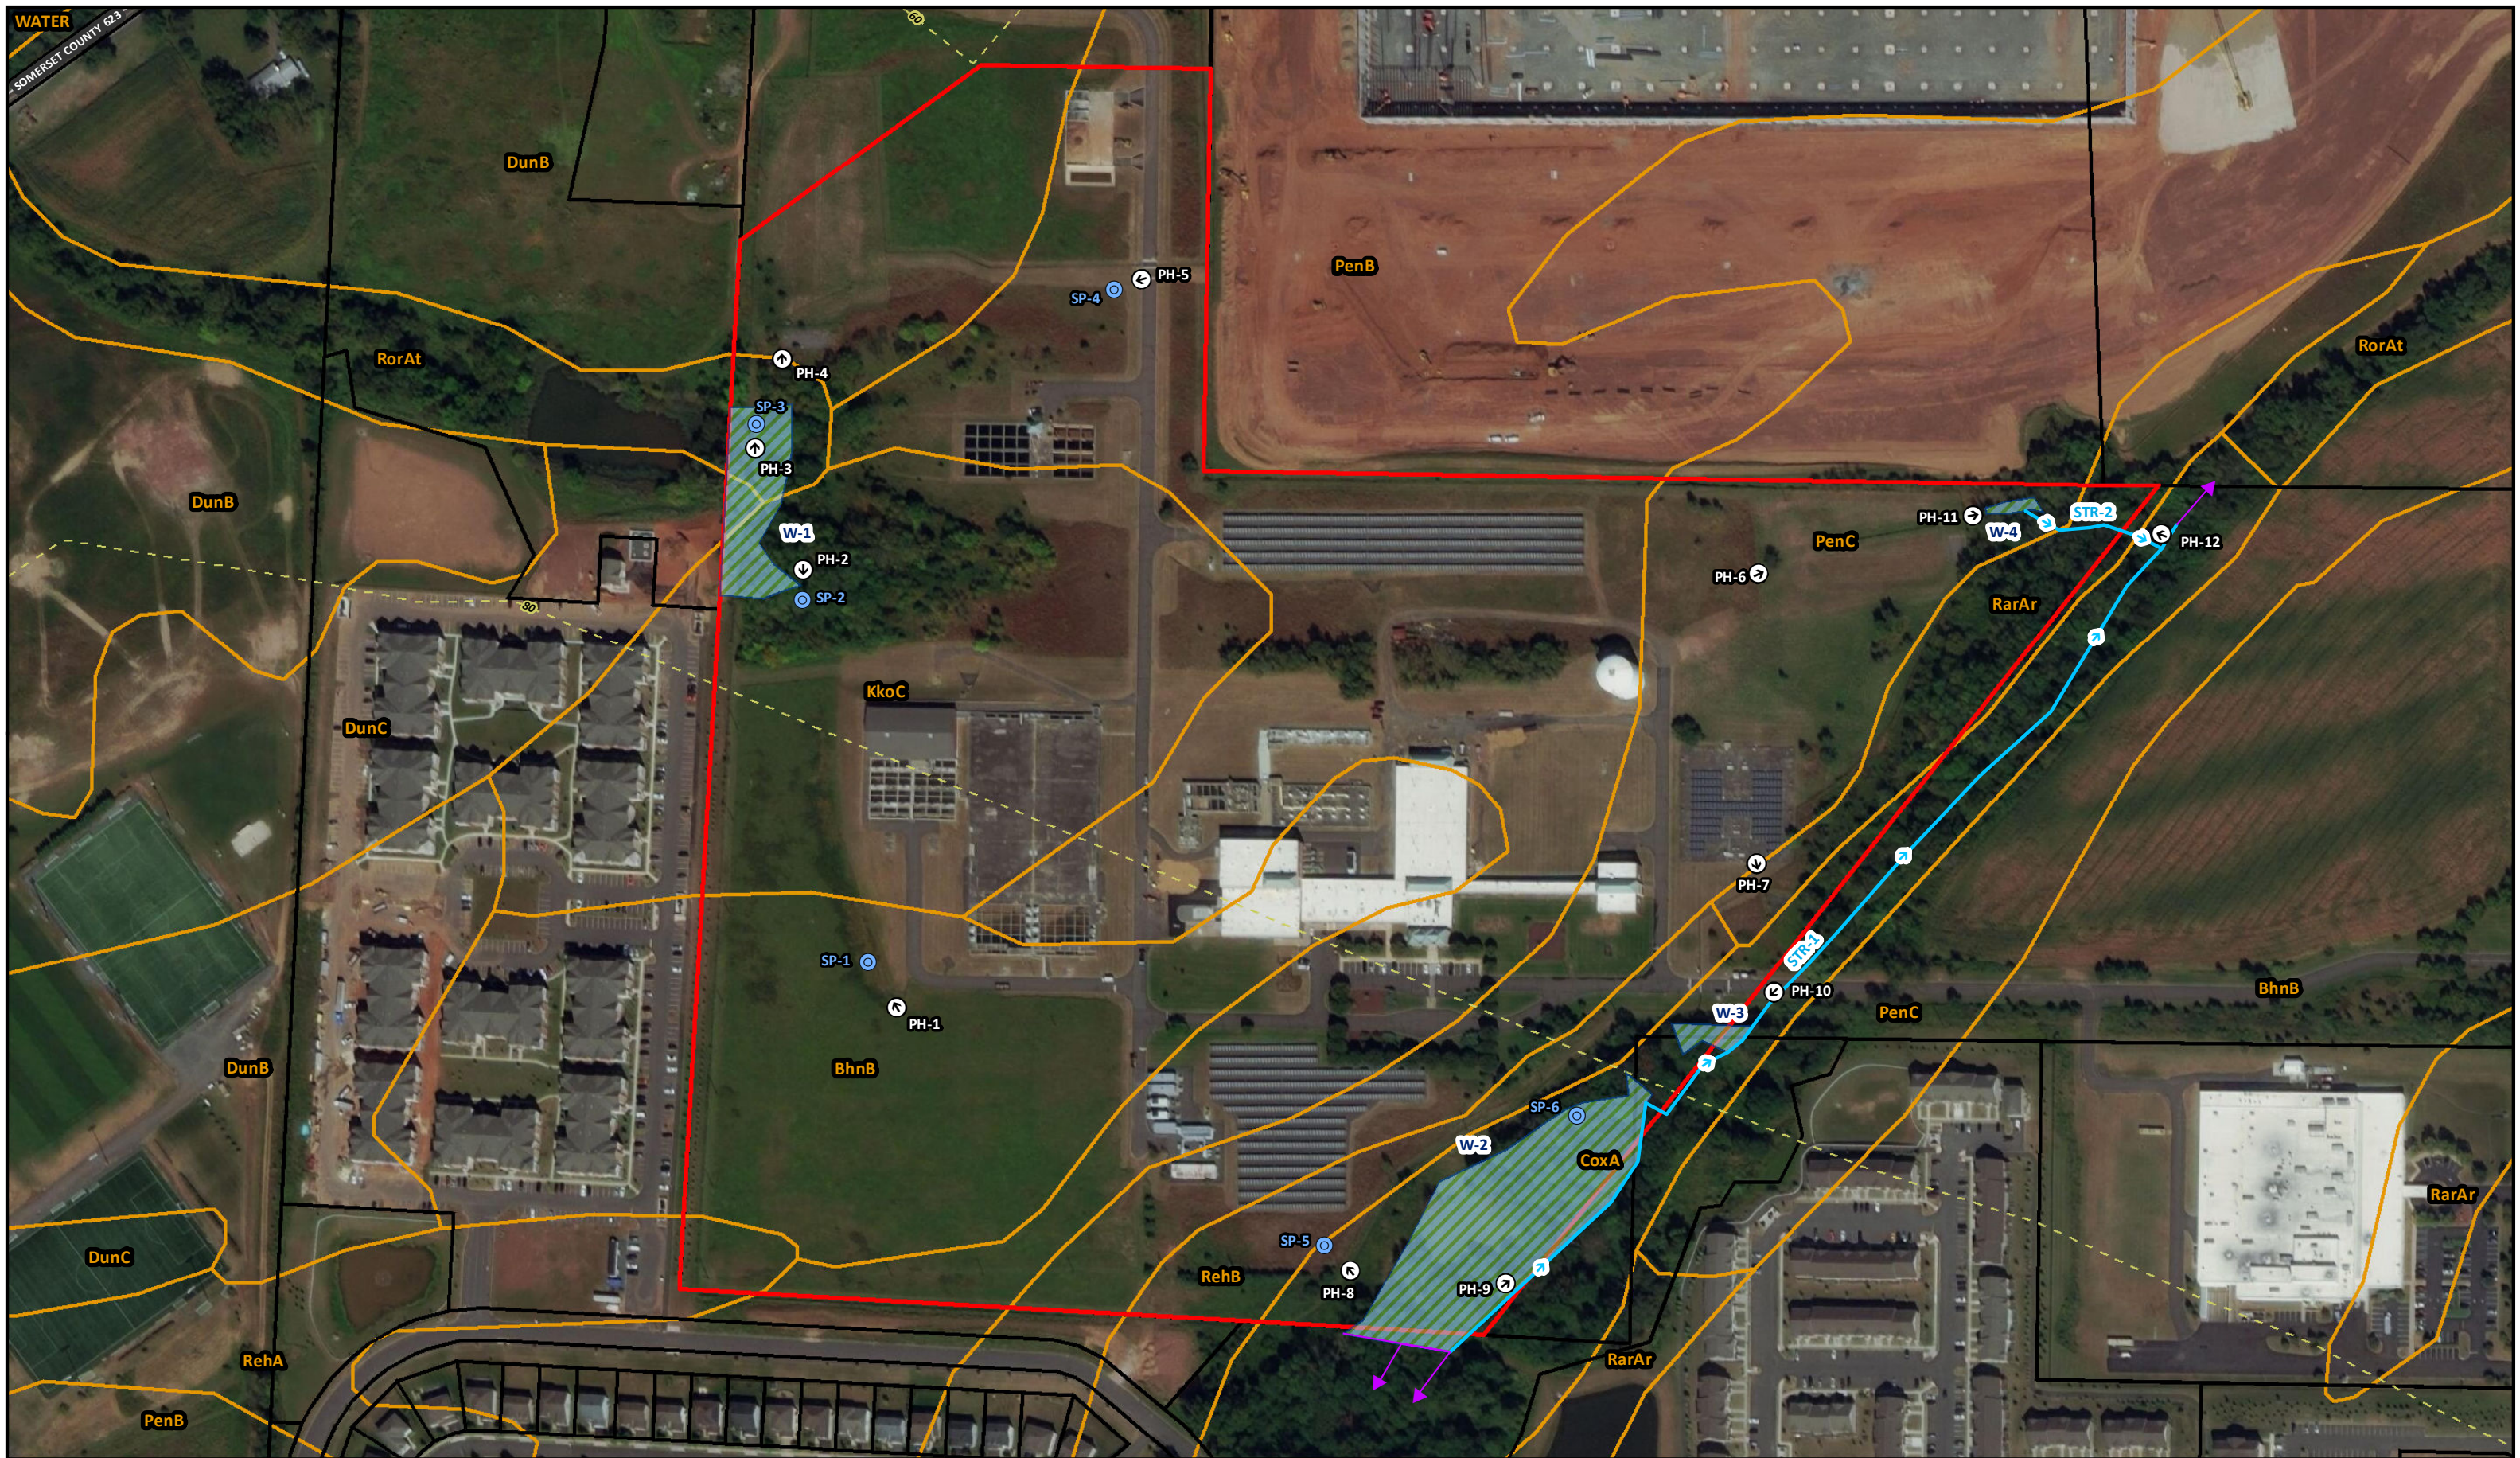
Figure 2 - Aerial Basemap

An aquatic resource investigation of the proposed Canal Road Solar Array project was conducted on May 18, 2021 by a qualified environmental scientist from RETTEW Associates, Inc. The proposed project includes the construction of various solar arrays on the New Jersey American Water property. The proposed project is in Franklin Township, Somerset County, New Jersey (**Attachment A, Figure 1**). The area of investigation (AOI) for the project included approximately 68.56 acres, which includes the existing developed facility and undeveloped areas on the property. Locations of all features identified within the AOI are shown on **Attachment A, Figure 2**.

One perennial stream and one intermittent stream were identified during the field investigation. These streams are Randolph Brook (STR-1) and an unnamed tributary (UNT) to Randolph Brook (STR-2). **Table 3** provides a summary of the identified streams. Locations of streams are illustrated on **Attachment A, Figure 2**.

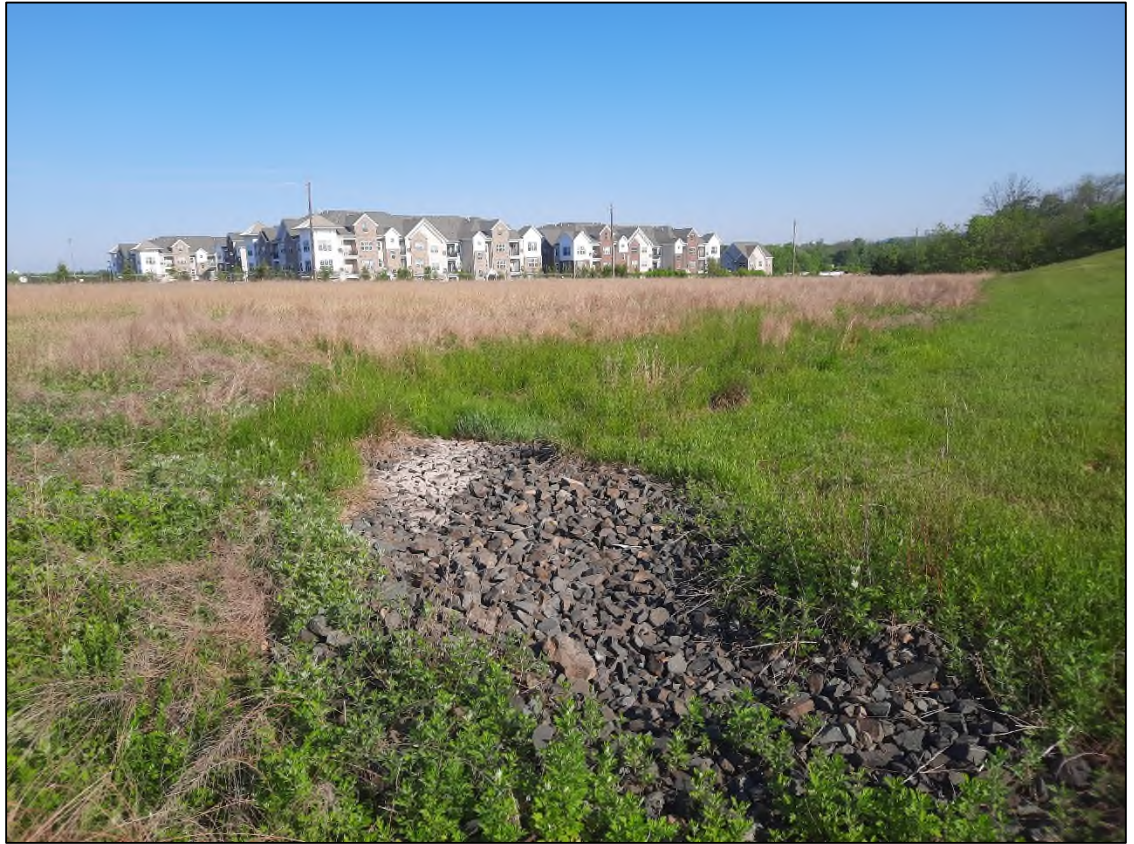
Photo 1

Comments:
View of upland
drainage swale
documented by
Sample Point 1 (SP-1).
The swale receives
discharge from a pipe
that infiltrates in a
closed swale.

Sample point located in closed swale. A discharge pipe and riprap apron is located at head of channel. Channel is closed on downstream end which leads to retention of water, which has led to development of hydrophytic vegetation. No signs of prolonged inundation. Soils are well drained and lack wetland hydrology and hydric soils. Based on review of aerials, ca. 2008, and site interviews, the area was disturbed during construction and the swale is a constructed feature.

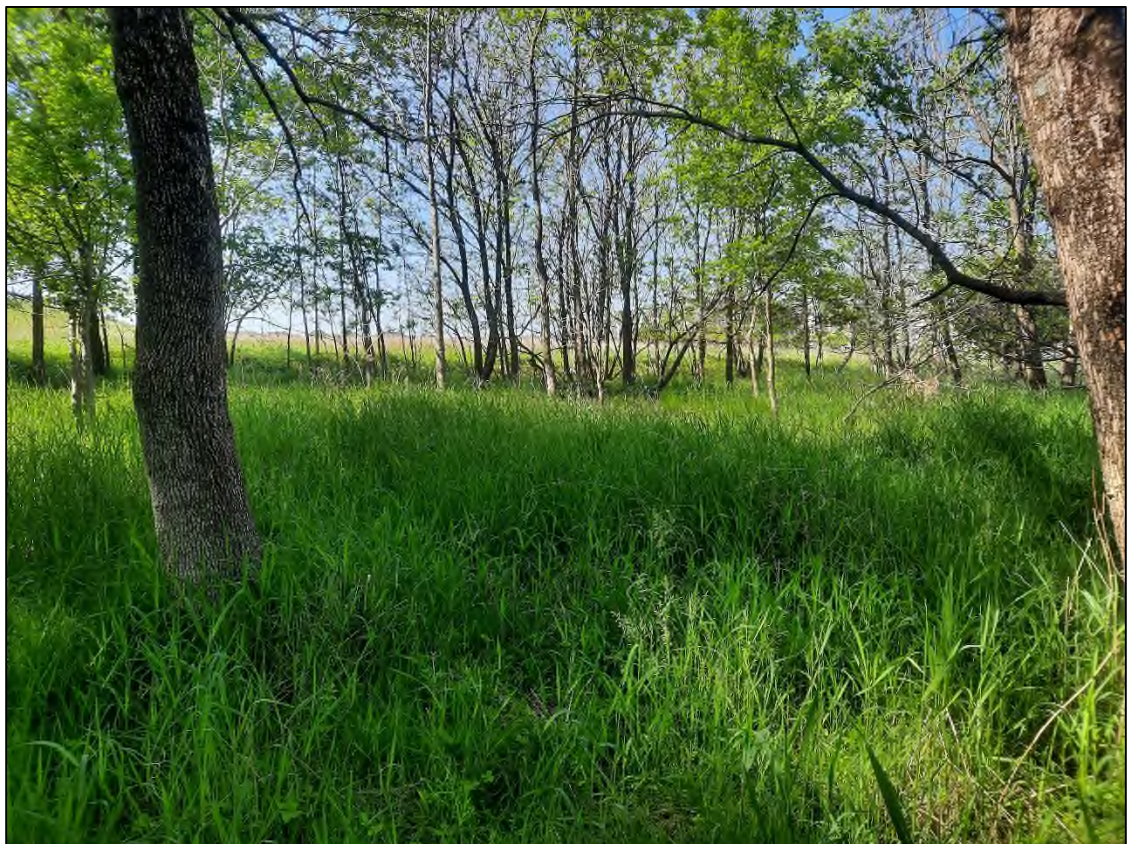
Photo 2

Comments:
View of the upland
forested habitat
documented by
Sample Point 2 (SP-2)
in the northwest
portion of the AOI. SP-
2 serves as upland
verification for the
nearby wetland.

Sample point located on a forested terrace. The area exhibits hydrophytic vegetation but lacks indicators of hydrology and hydric soils.

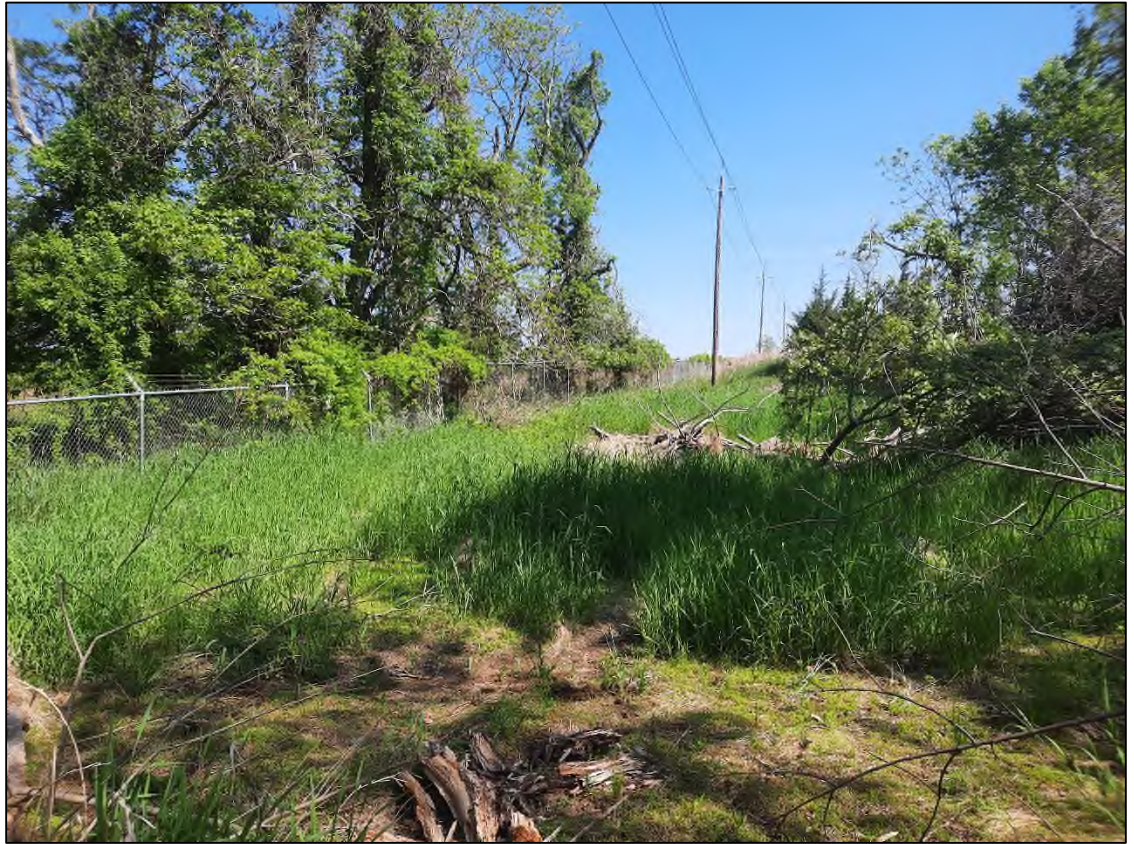
Photo 3

Comments:
View of Wetland 1 (W-1) that was documented by Sample Point 3 (SP-3) in the northwest portion of the AOI. The wetland contains PEM habitat along the western portion and PFO habitat along the eastern portion.

Sample point is representative of Wetland 1 located in a low lying area at the edge of the property. This area receives surface runoff from the property which is evident based on drainage patterns.

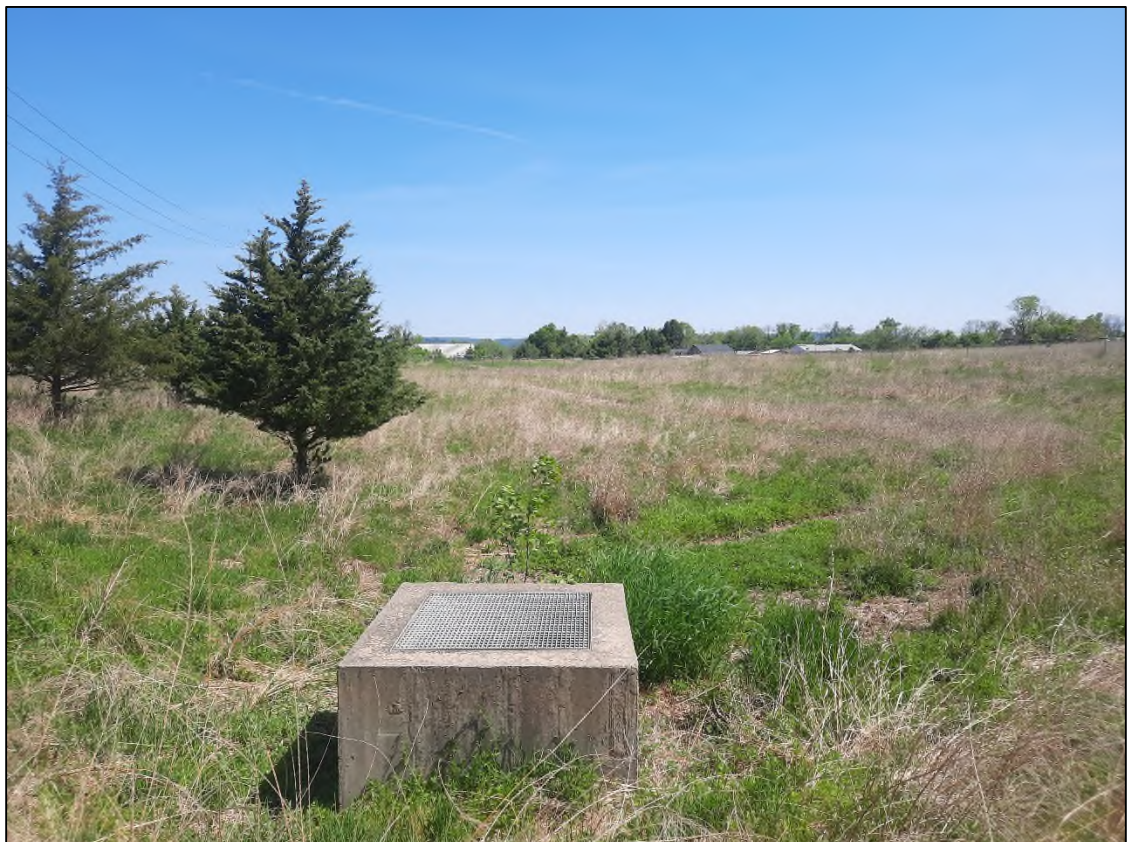
Photo 4

Comments:
View of a constructed stormwater facility in the northwest corner of the AOI.

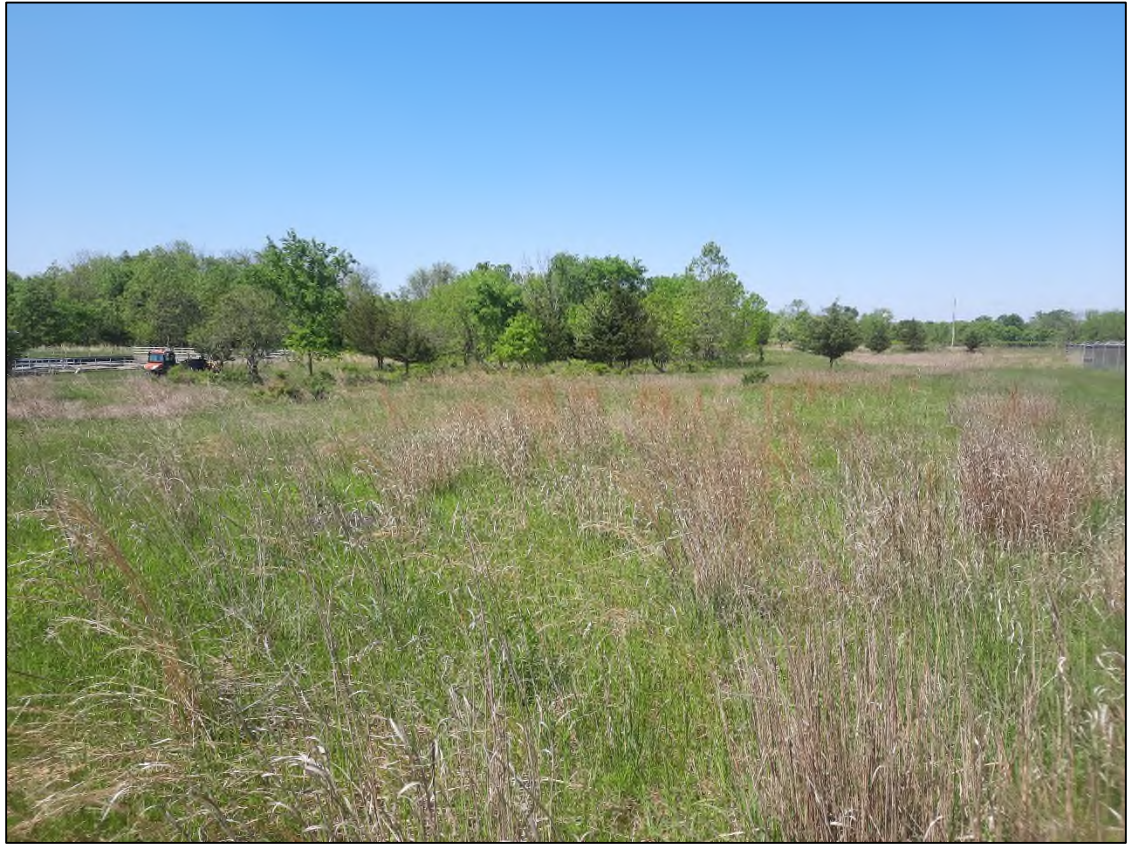
Photo 5

Comments:
View of an upland
fallow field located in
the northern portion of
the AOI. The area was
documented by
Sample Point 4 (SP-4).

Sample point located on a terrace that consists of fallow field. Area appears to be periodically mowed. Additionally, soil appears to be compacted fill material (not recent).

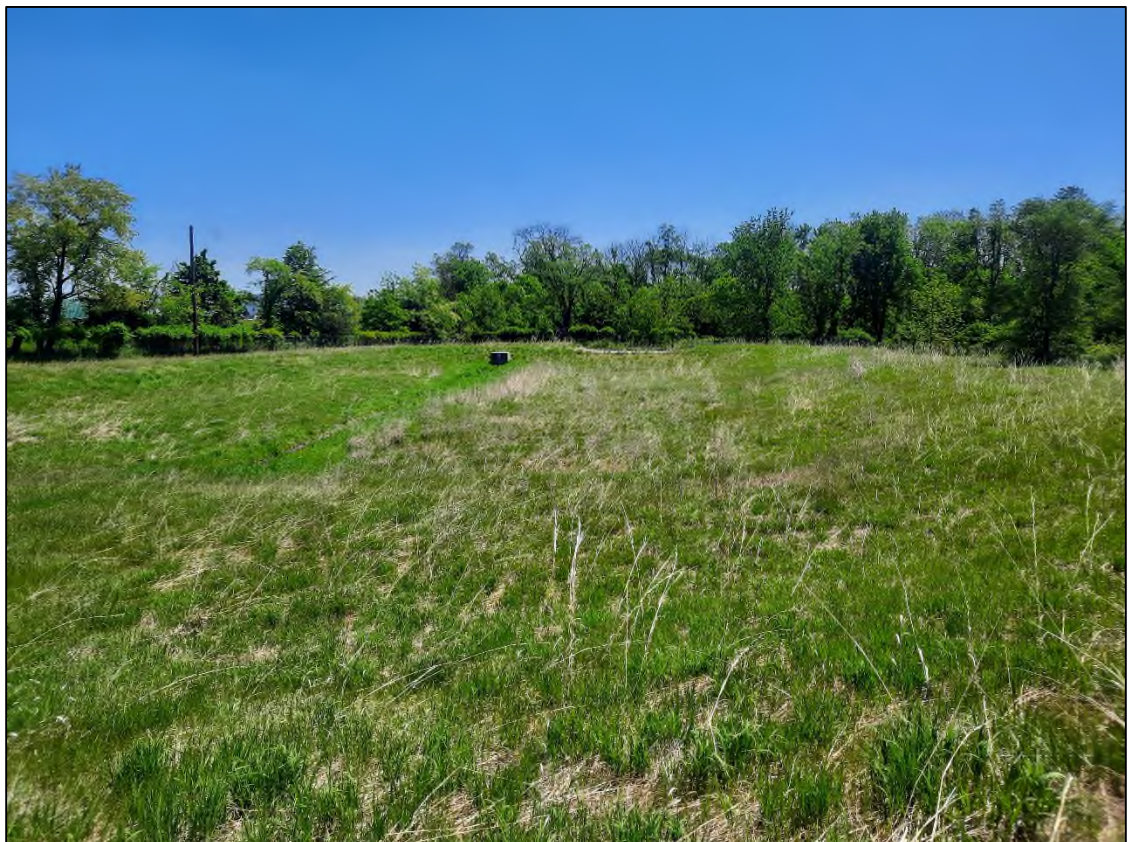
Photo 6

Comments:
View of a constructed
stormwater facility in
the northeast portion
of the AOI.

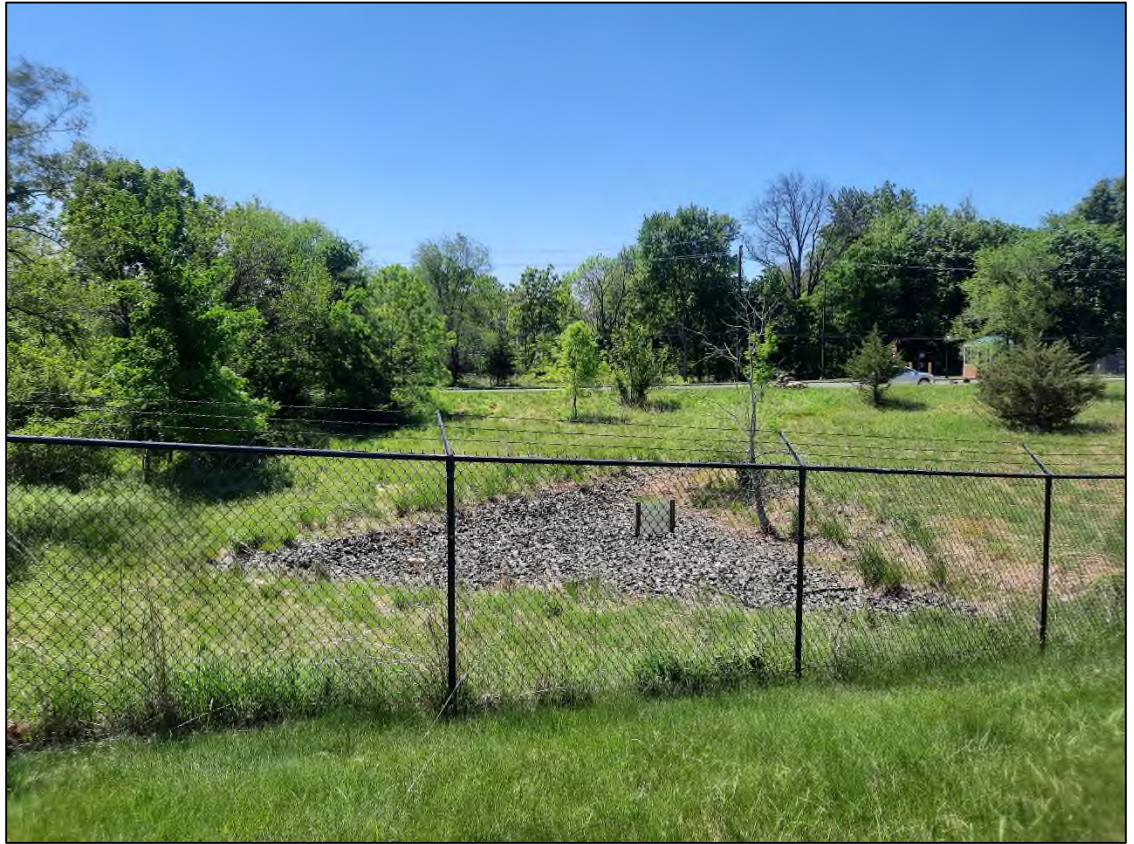
Photo 7

Comments:
View of a constructed
stormwater facility in
the east-central
portion of the AOI.

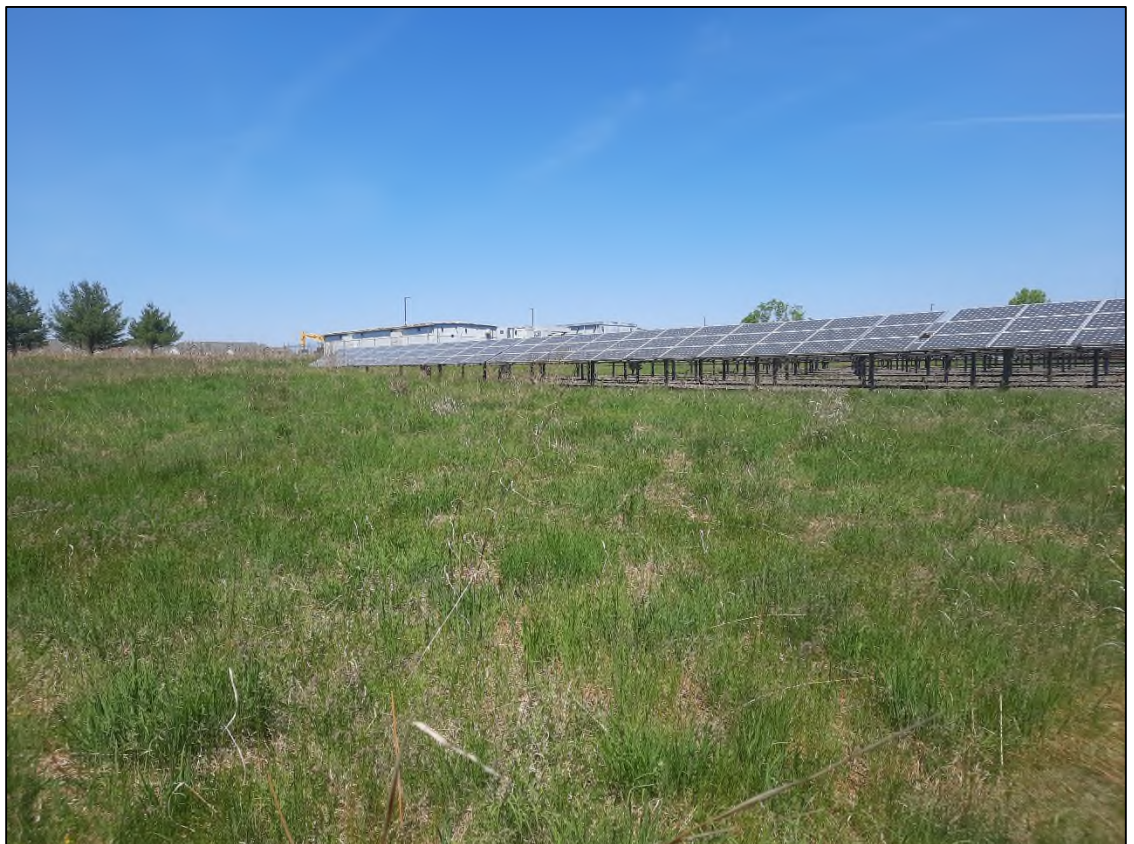
Photo 8

Comments:
View of an upland
fallow field in the
southeast portion of
the AOI. The upland
condition was
documented by
Sample Point 5 (SP-5).

Rationale: Soil is included on hydric soil list but area does not exhibit hydric indicators. Area appears to be previously disturbed and may consist of fill material.

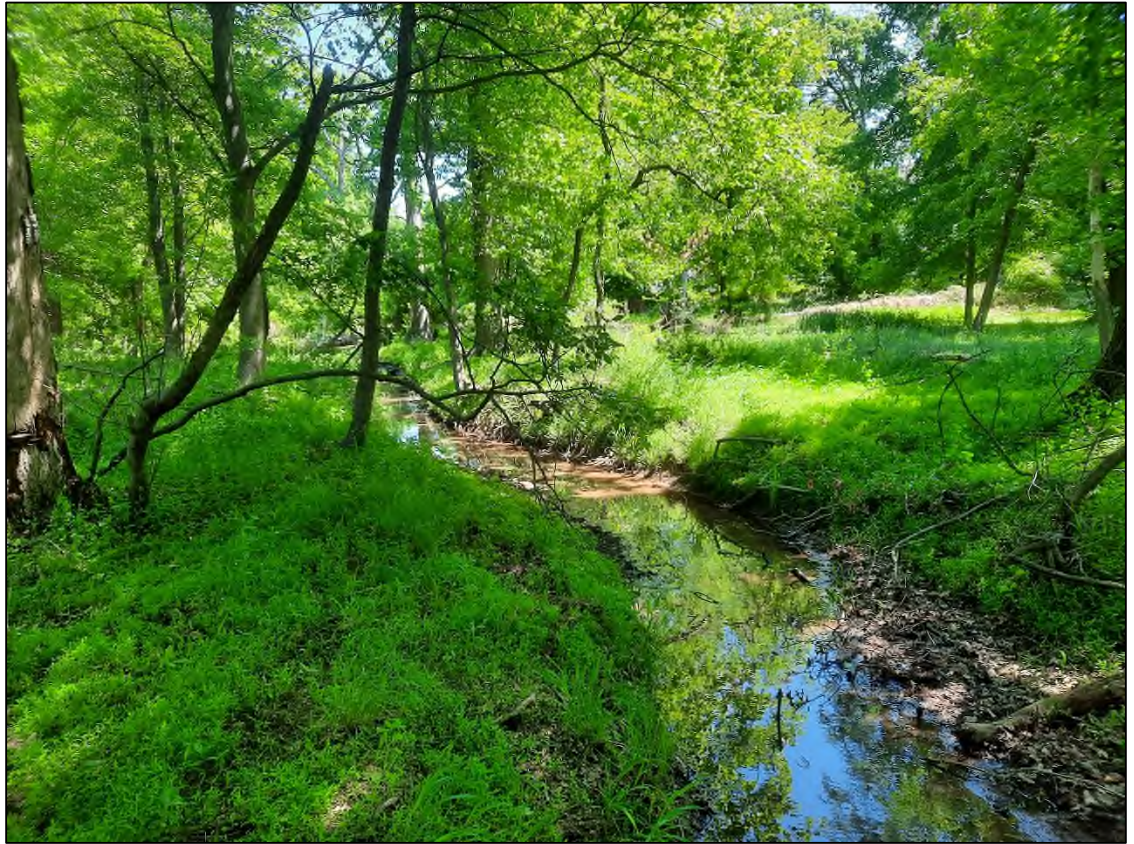
Photo 9

Comments:
View of Stream 1 (STR-1), identified as Randolph Brook a perennial stream, located along the eastern portion of the AOI. Wetland 2 (W-2) is located along the western edge of the stream. W-2 consists of PEM and PFO habitat.

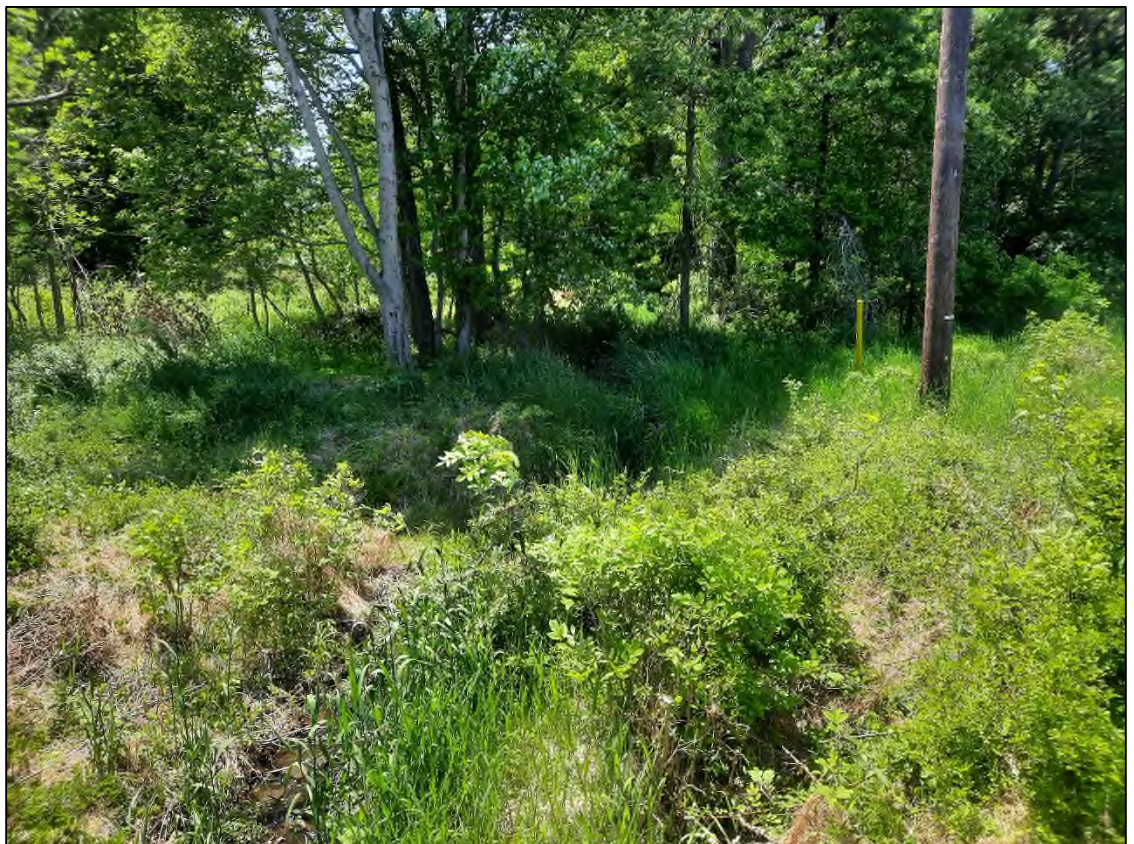
Photo 10

Comments:
View of STR-1 which is obscured by herbaceous vegetation and Wetland 3 (W-3) from the existing site access road in the east-central portion of the AOI.

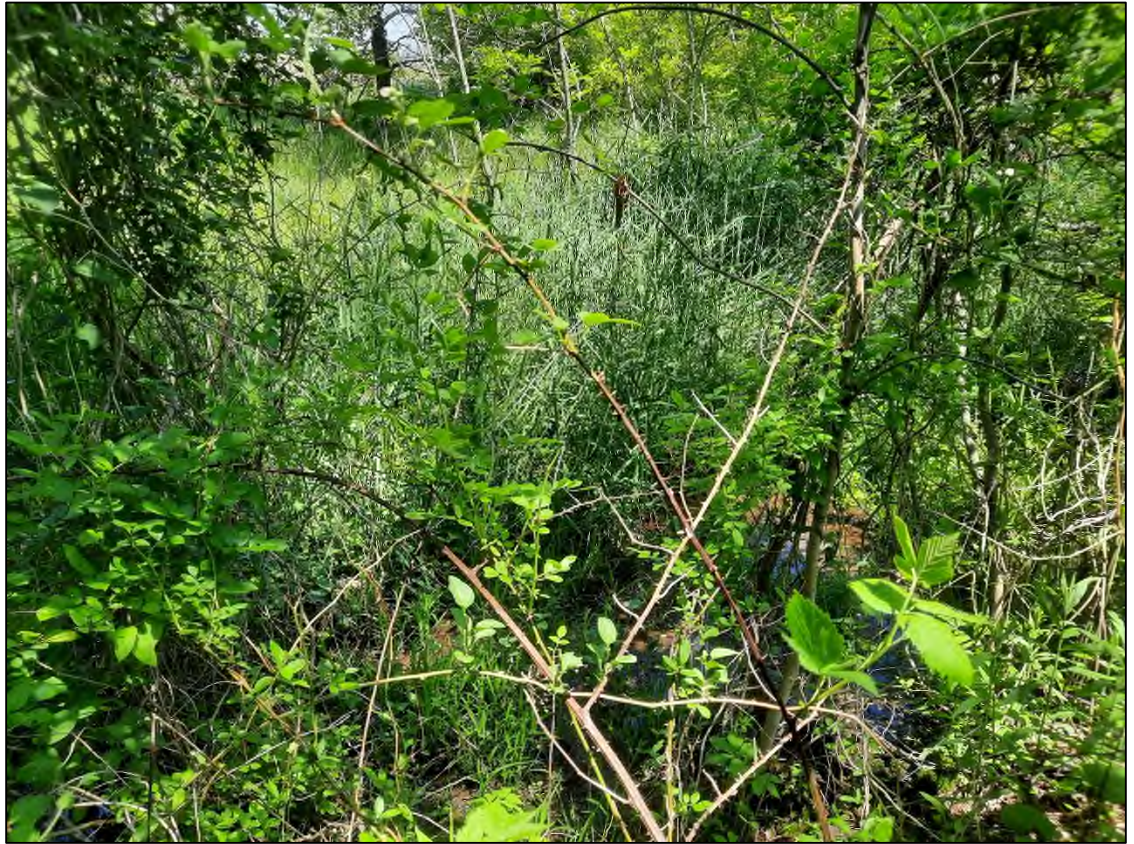
Photo 11

Comments:
View of Wetland 4 (W-4) a small PEM wetland located in the northeast corner of the AOI. The wetland receives direct discharge from the nearby stormwater facility and is underlaid with rip-rap scour protection.

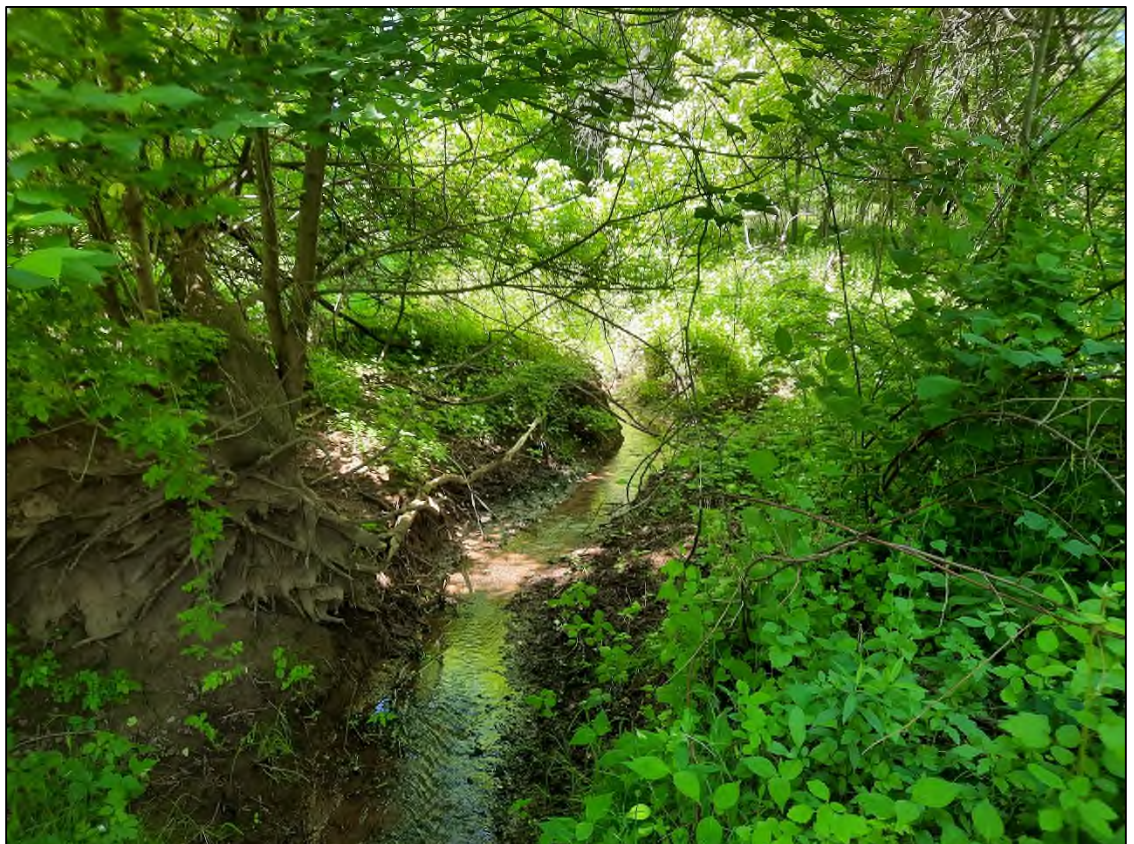
Photo 12

Comments:
View of Stream 2 (STR-2), an intermittent stream, that connects W-4 to STR-1.
