TYPE & TIME OF OCCUPANCY

FOR THE PROPERTY AT

264 Girard Ave, Somerset, NJ

February 28, 2024

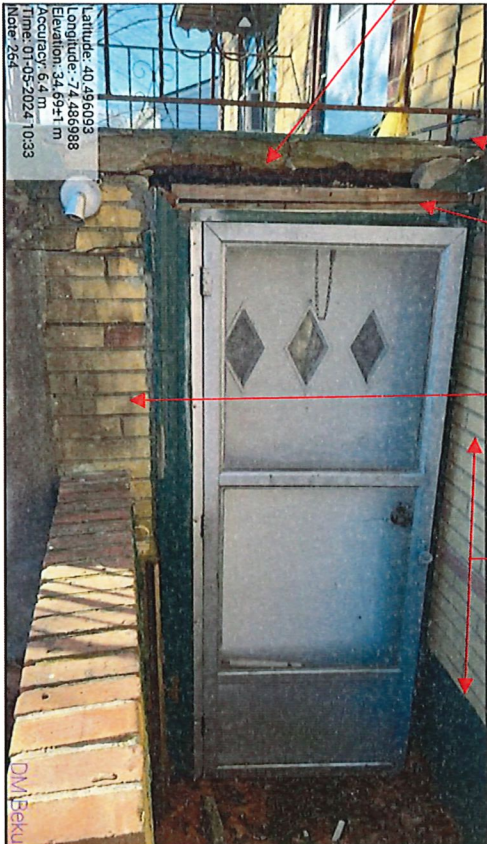
Side entrance under the front porch.

The framing indicates attempted later repairs to the door frame.

The brick work on the side entrance matches the brick on the home, indicating contemporaneous construction.

The fact the front brick continues below grade indicates it was part of the original construction.

The retaining wall has a different brick and was likely a repair at some point in the past.

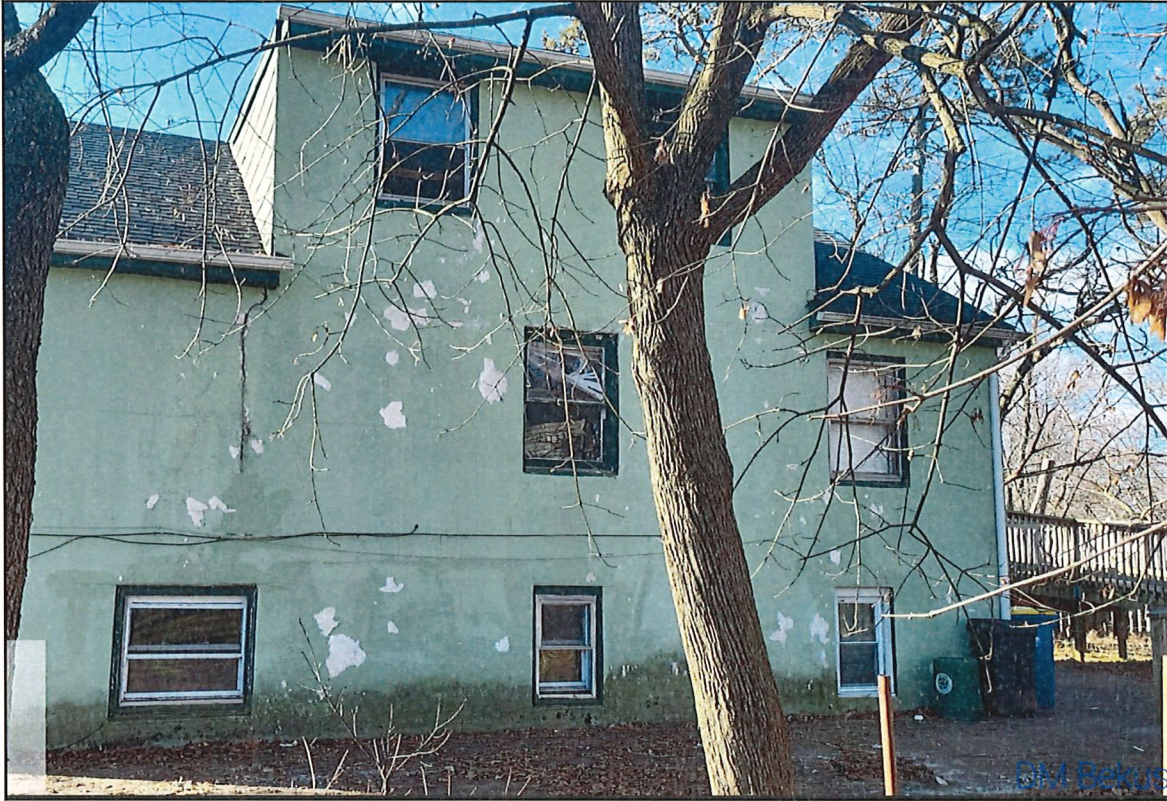
Right side

The plaster siding is continuous from grade level to roof line, including the second floor. Other than having been painted over time, the plaster siding is the original siding from the construction of the home. The window size and configuration of the basement windows shows an intent for occupancy. Almost universally, basements from before the 1960s consisted of low ceiling heights and extremely few, small windows. The basement in this 1953 home is unusual in that there are multiple large windows, strongly indicating an intent for occupancy. There are no indications the windows were added after the initial construction. Even the size of the windows indicates an intent for occupancy because the far left window width and height can be associated with a typical living room or common room, and the two other windows are typical for bathrooms and kitchens from the period.

The upper floor wall being plastered as part of the original construction and the two large windows indicate an original intent for occupancy and not a later attic addition.

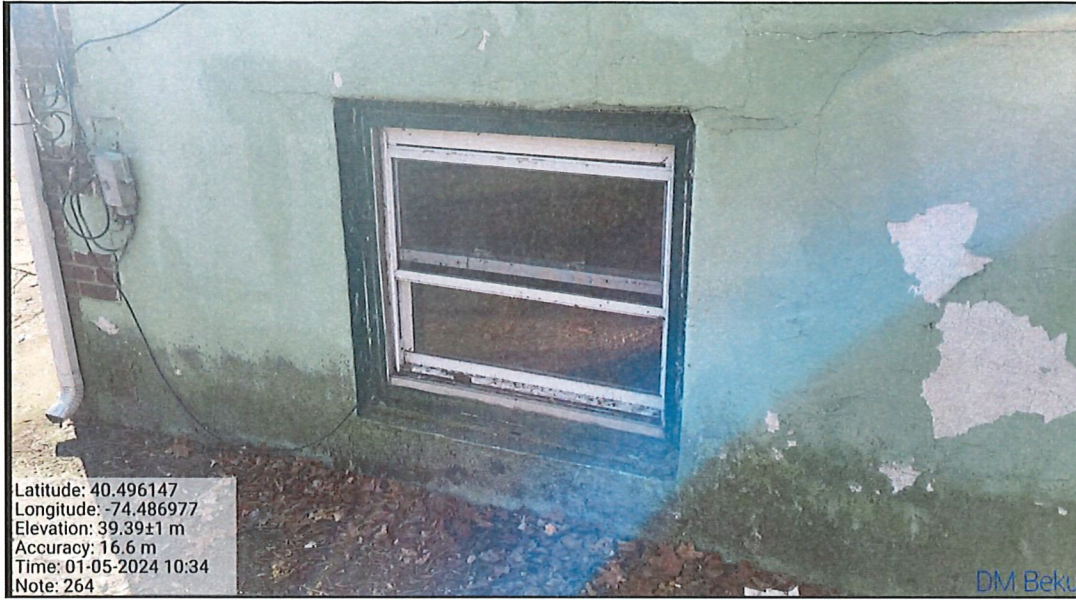
The window frame and plaster (note how it is let in to the front brick) indicate it is part of the original construction. The window itself is a vinyl replacement window.

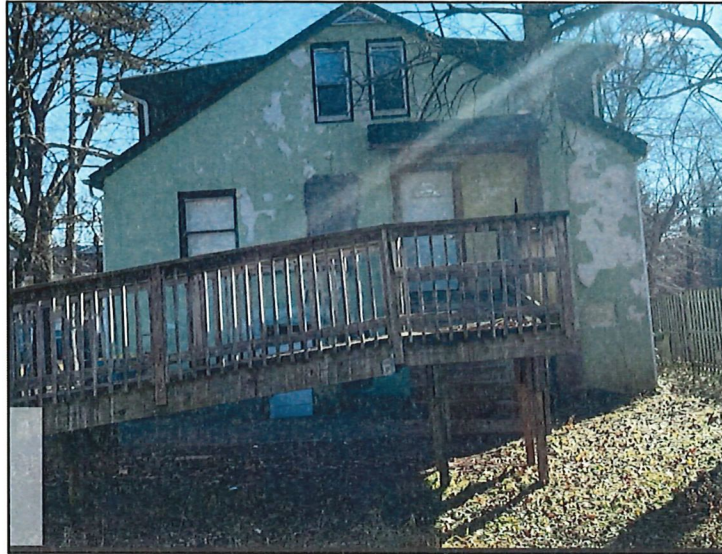
The rear of the home has two entrances. The rear entrance retaining walls are part of the original construction. It appears that at one time there was a canopy over the entrance.

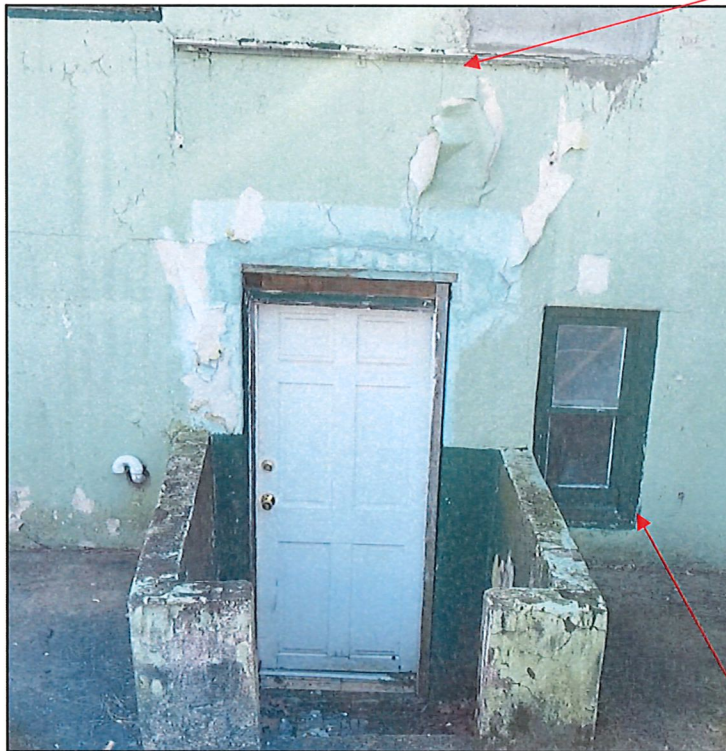
The original small window indicates an intent for occupancy by the original builder and designer.
The door has likely been replaced several times over the life of the building.

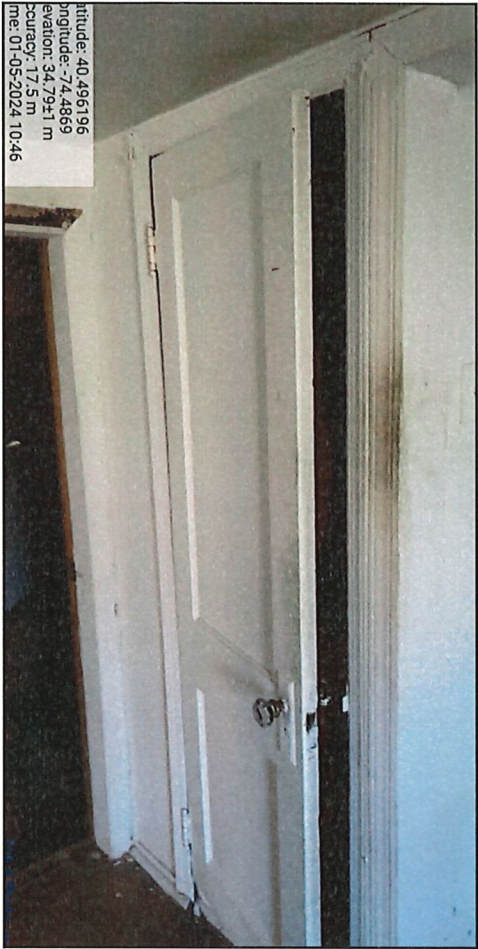
Most of the interior doors and floors have been replaced over time. The door shown below is the only original interior door I found. The style, hinge, and doorknob are typical of 1930s to 1950s construction.

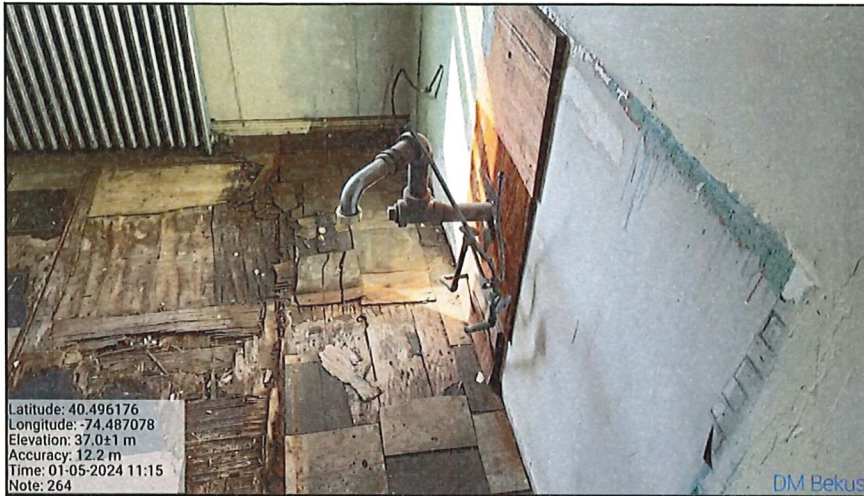
Basement kitchen cabinets have been removed.

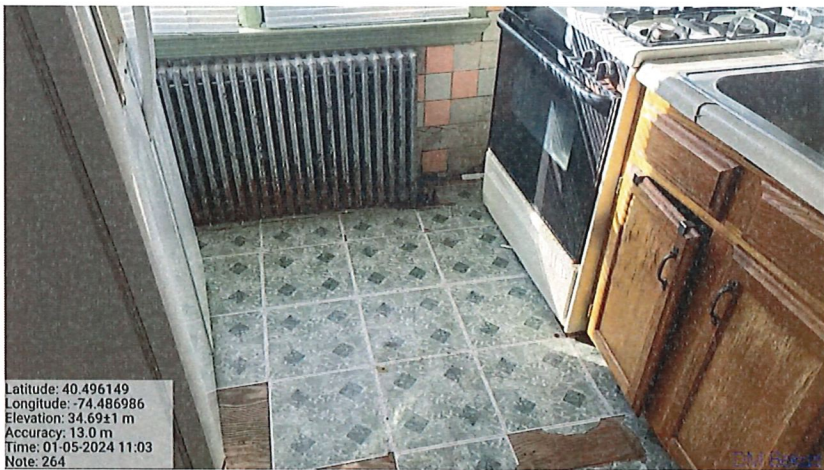
First floor cabinet

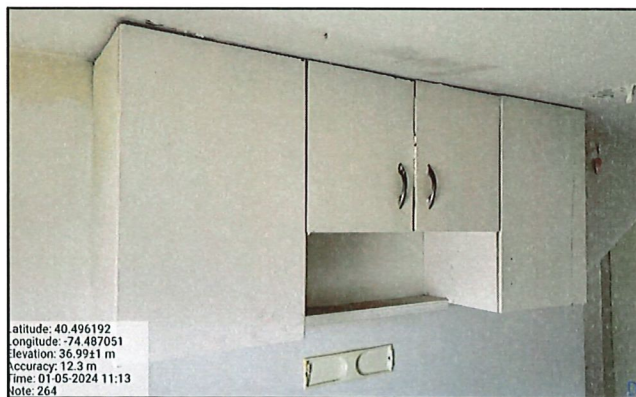
Third floor cabinets; the metal cabinets as shown above are typical for 1930s through 1950s construction.
