GEOTECHNICAL ENGINEERING REPORT

Wilf Campus for Senior Living – Proposed Solar Field

Franklin Township, Somerset County, New Jersey

January 2022

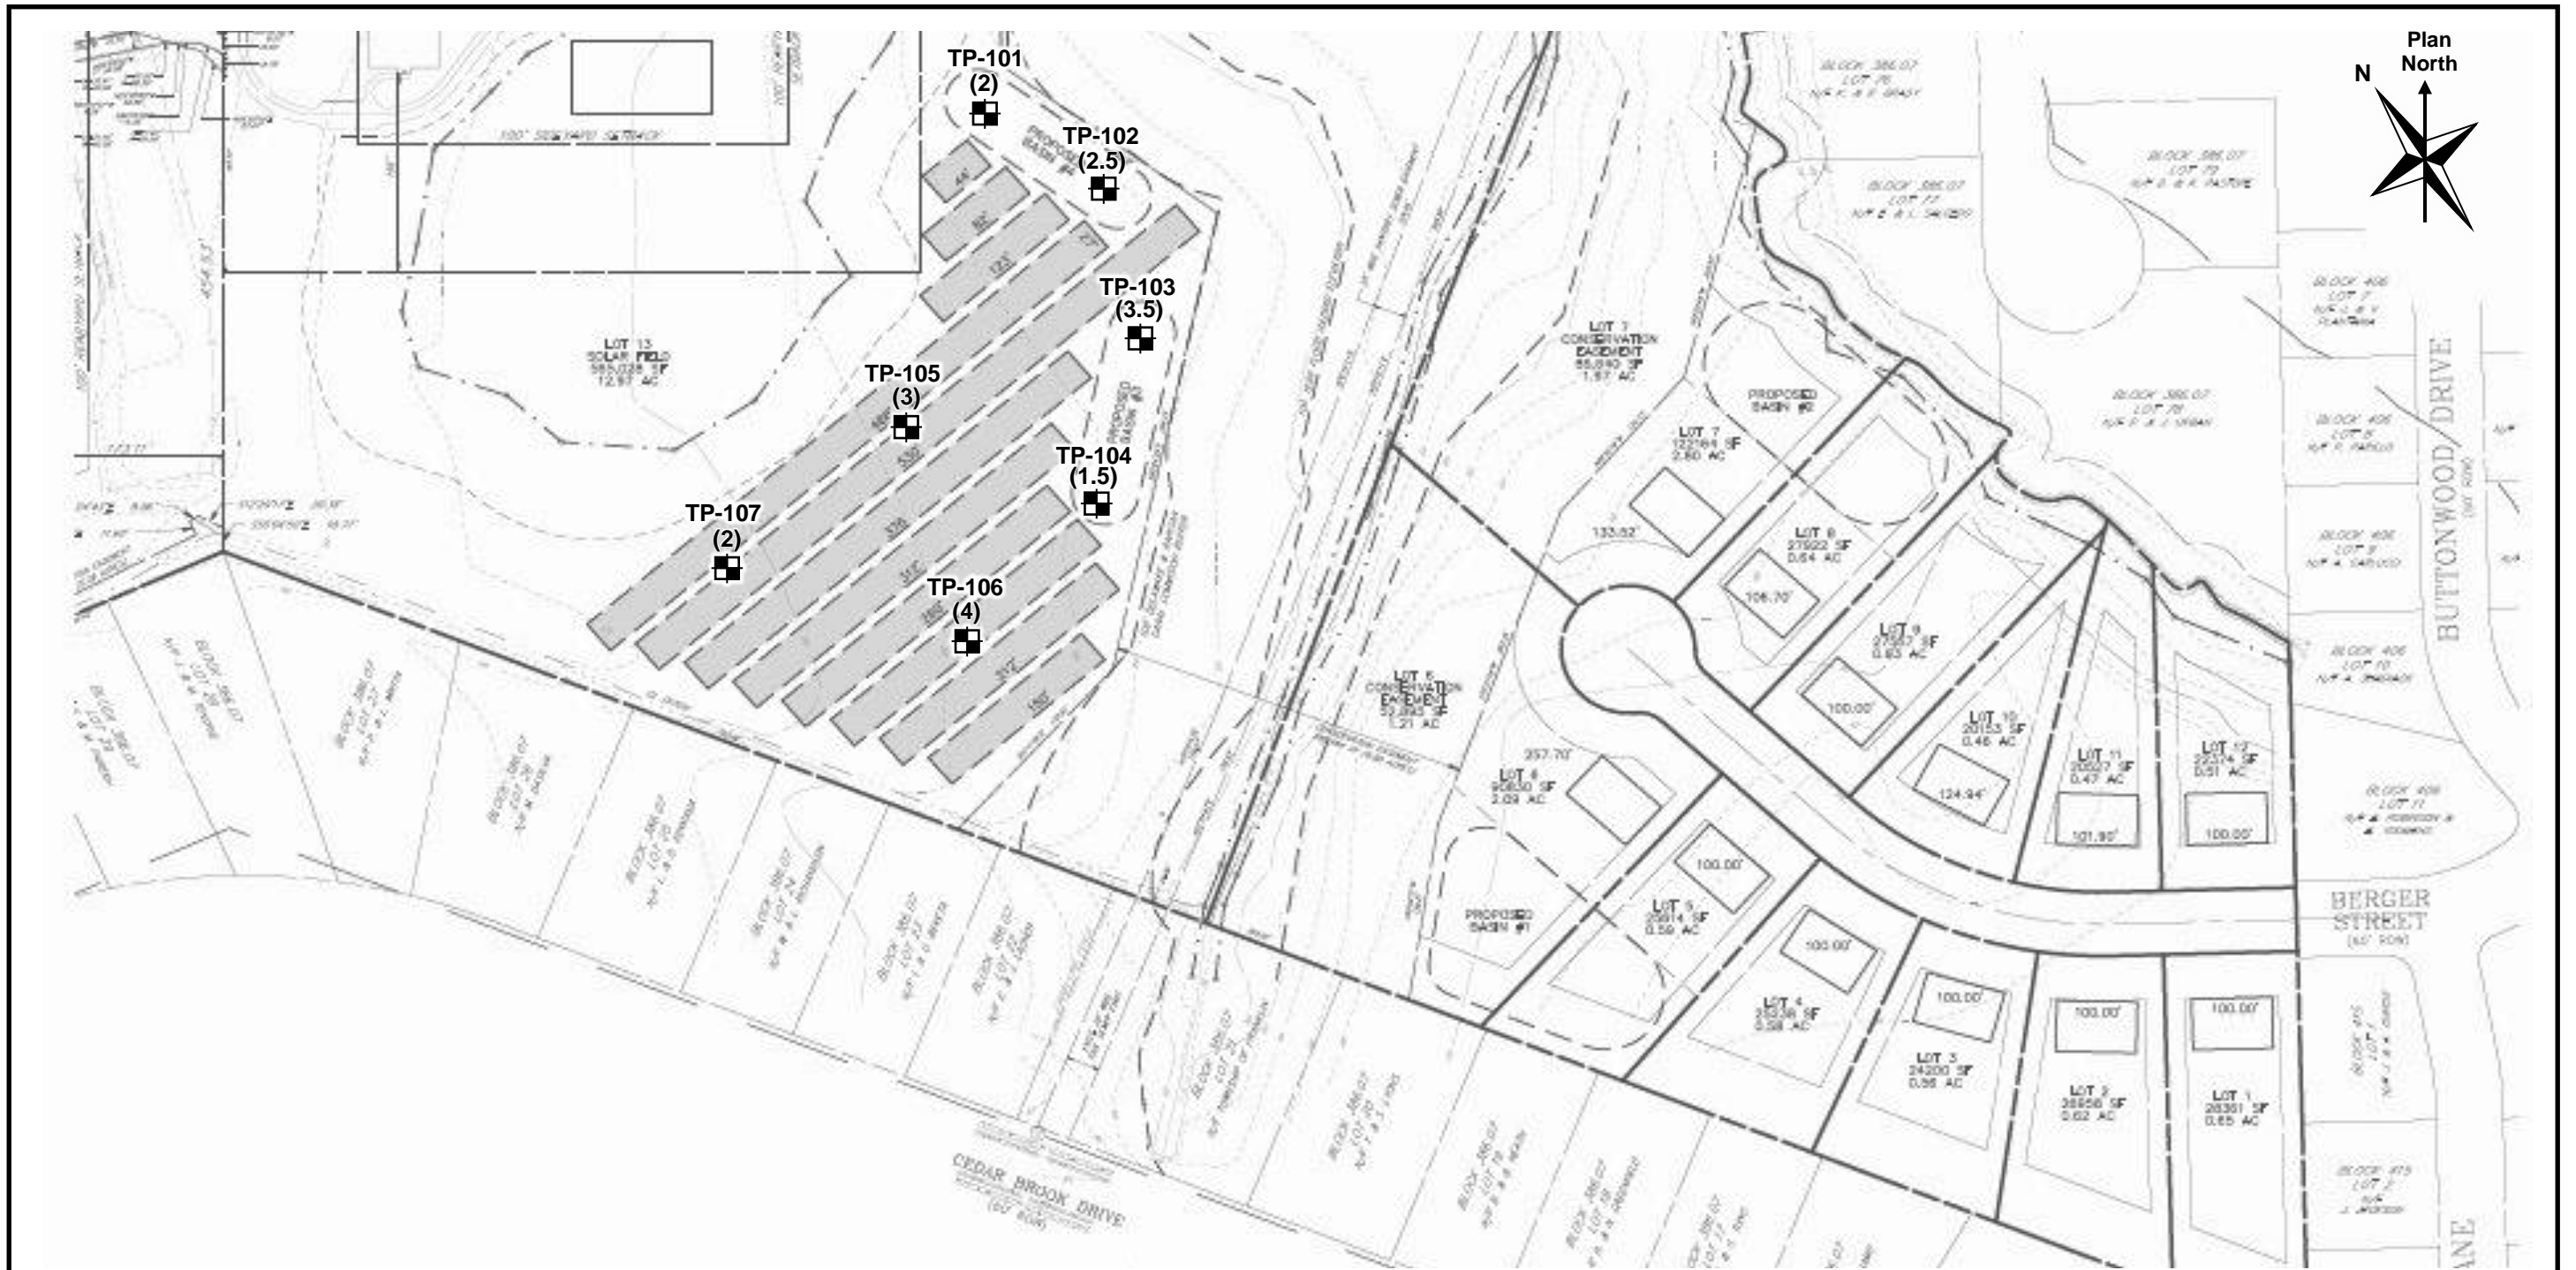
*Baseplan prepared by Menlo Engineering Associates, Inc. titled "Concept Plan" dated August 3, 2021.

The exploration locations were selected by GTA, and located in the field using a hand-held GPS unit and existing site features as reference. The approximate locations of the explorations performed by GTA for this study are shown on the Test Pit Location Plan, which is included as Figure 2 in Appendix A. Detailed descriptions of the subsurface conditions encountered in the test pits observed by GTA are indicated on the Logs of Test Pits, which are included in Appendix B. The ground surface elevations indicated on the test pit logs were obtained by interpolating between topographic contours shown on the plan provided to us and should be considered approximate.

purposes, the approximate depths below the existing surface grades to the surface of highly-weathered rock are shown at the individual test pit locations on the Test Pit Location Plan in Appendix A.

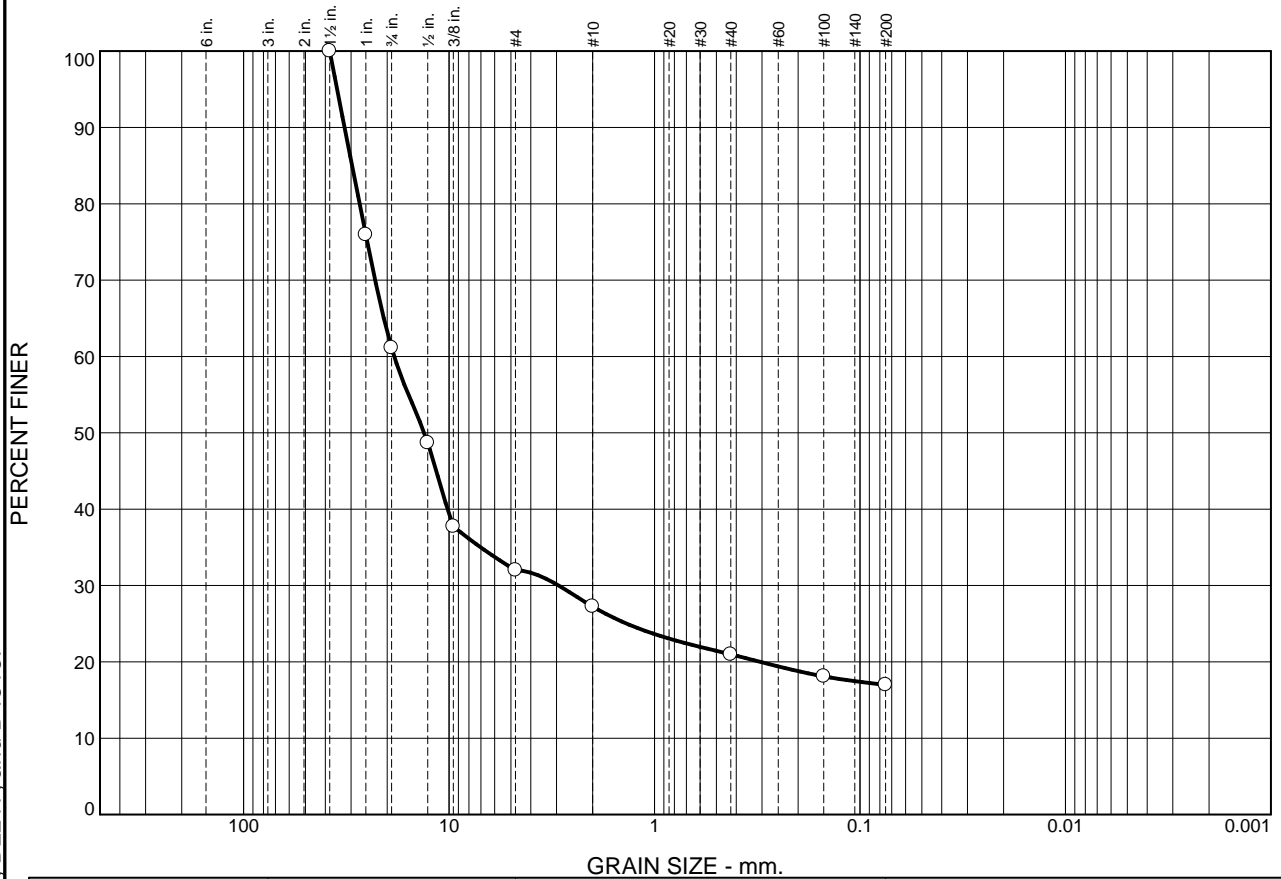
Particle Size Distribution Report

% +3"	% Gravel		% Sand			% Fines	
	Coarse	Fine	Coarse	Medium	Fine	Silt	Clay
0.0	38.9	29.1	4.8	6.2	4.0	17.0

TEST PIT LOCATION	DEPTH (ft.)	USCS CLASSIFICATION	NMC (%)
TP-101	½	Silty GRAVEL with sand (GM)	16.7
TP-103	1	Silty GRAVEL with sand (GM)	16.3
TP-106	¾	Silty SAND with gravel (SM)	15.7

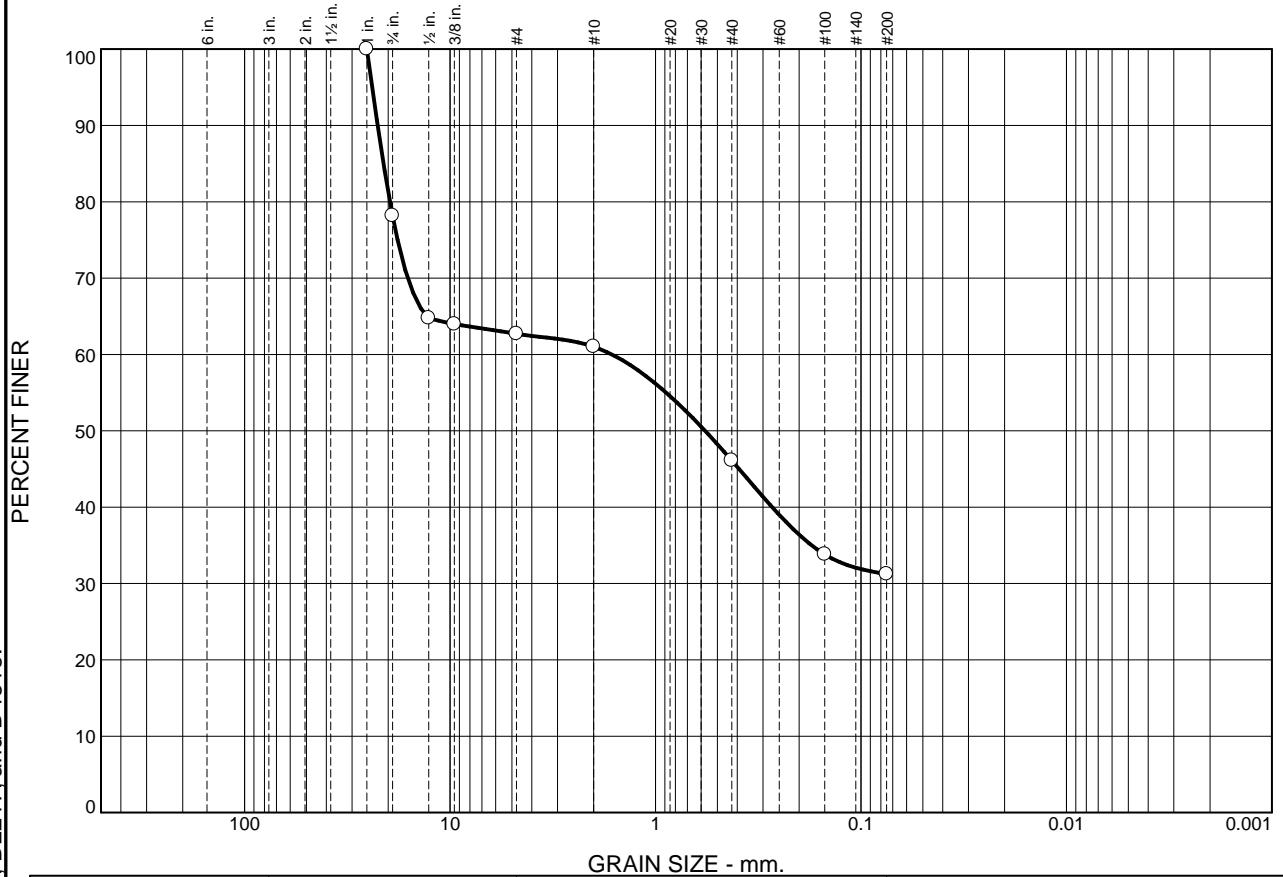
Particle Size Distribution Report

% +3"	% Gravel		% Sand			% Fines	
	Coarse	Fine	Coarse	Medium	Fine	Silt	Clay
0.0	21.8	15.5	1.7	14.9	14.9	31.2

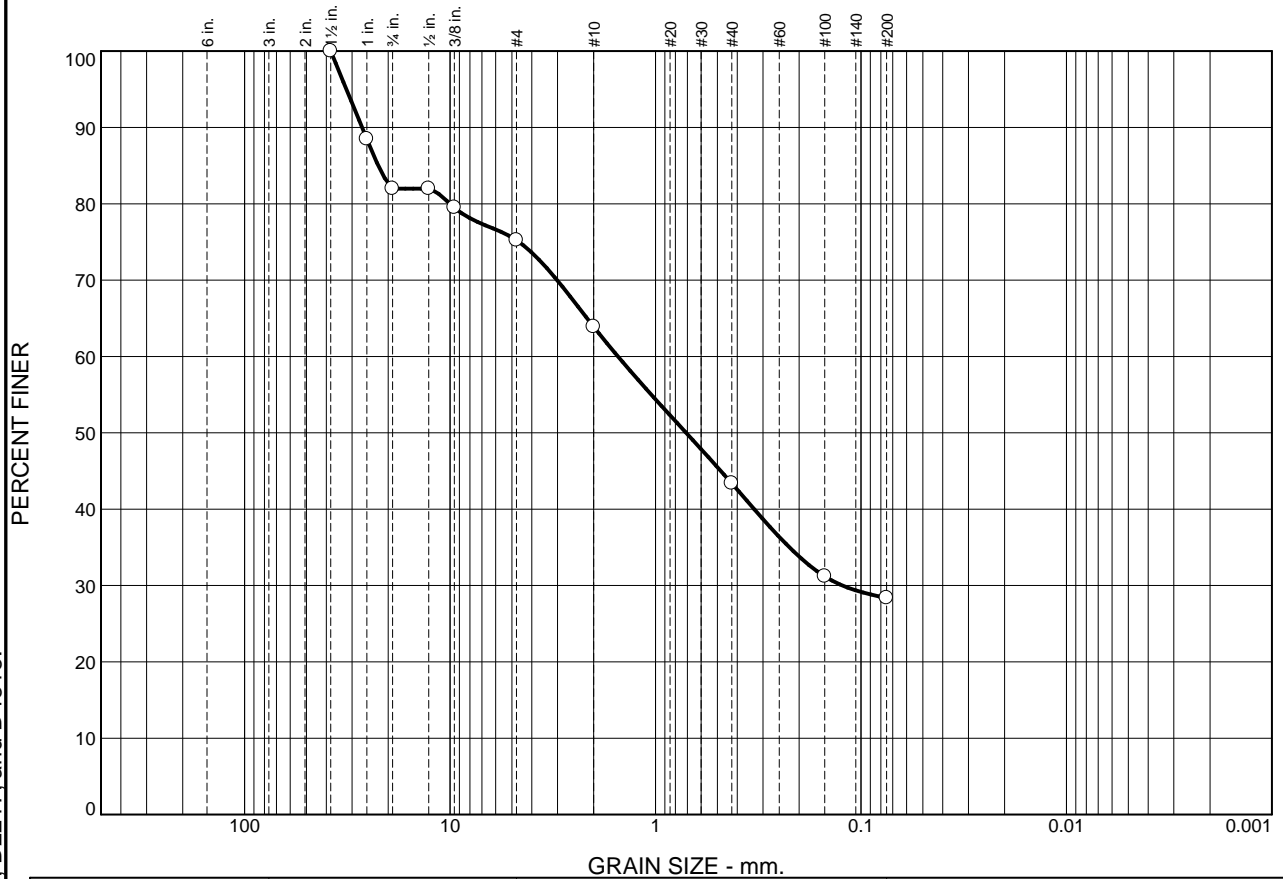
Particle Size Distribution Report

% +3"	% Gravel		% Sand			% Fines	
	Coarse	Fine	Coarse	Medium	Fine	Silt	Clay
0.0	18.0	6.8	11.3	20.5	15.0	28.4
